Transport Safety Investigation Bureau
Safety Flyer – 2019/02

The importance of ensuring proper inspection and maintenance regime

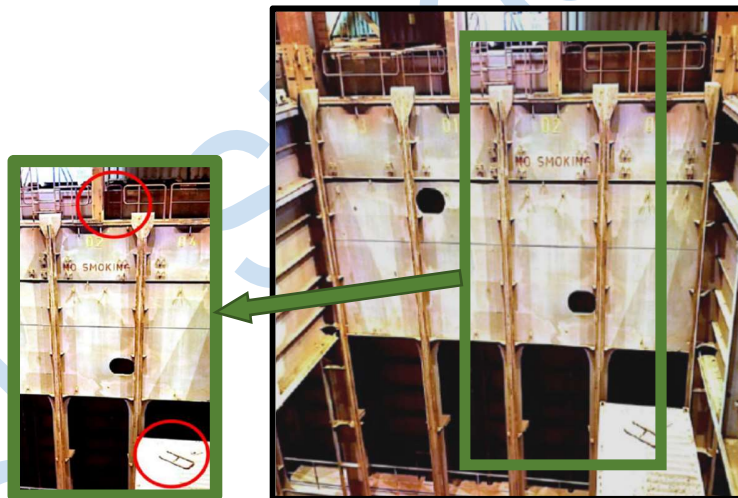
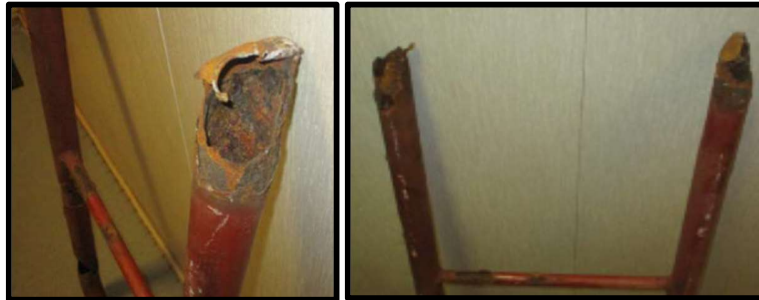
2. Preliminary findings from a marine casualty resulting in a stevedore being fatally injured by falling into the cargo hold of a container ship, revealed that a safety railing, which was in poor condition² and badly corroded, could have contributed to the fall of the stevedore through a height of about 20 metres. Although the corroded safety railing had been identified to be one of the tasks to be carried out on board, there were no safeguards or warning signs put in place to warn personnel in the vicinity of its condition.

Picture 1: Closer examination of the railing revealed severe corrosion (metallurgy thinning) at the bottom joints

9. Safety barriers / gratings are meant to protect personnel from potential hazards, such as prevention of falling from height. Where safety barriers / gratings are found to be corroded such that their main role of providing functions could be compromised and pose a threat to personnel, shipboard staff should take appropriate mitigating measures by putting up warning signs and cordoning off such areas to the extent practicable and make such observations known to the company.

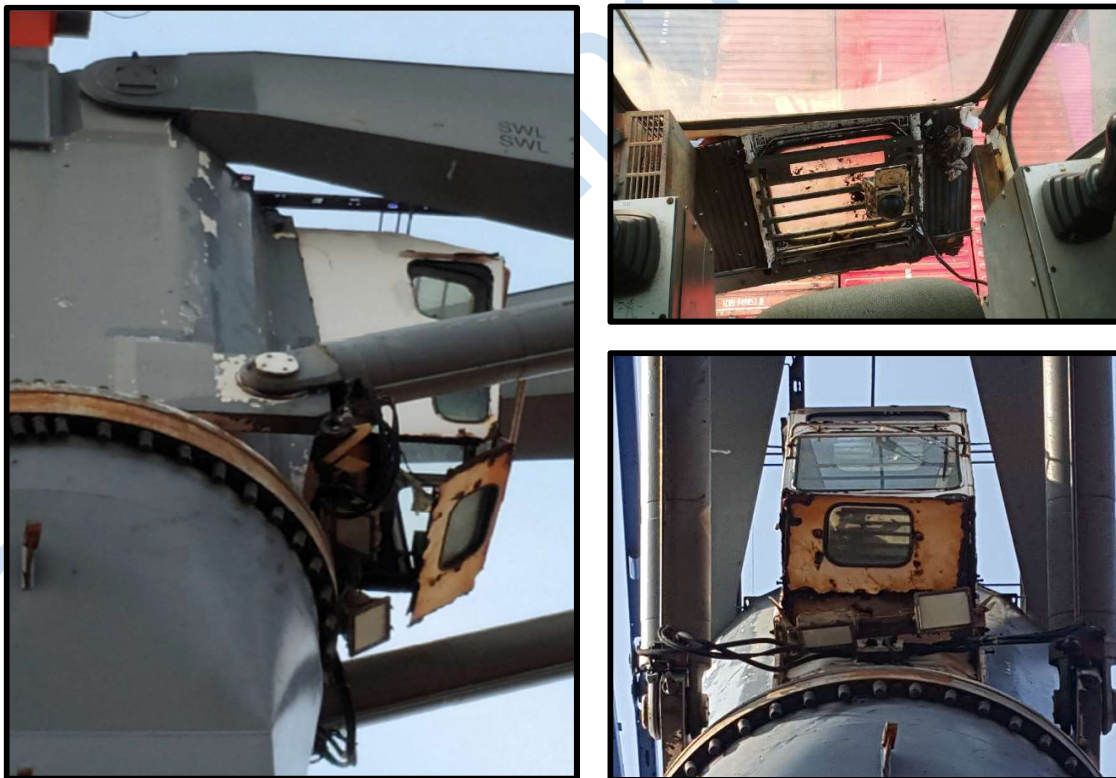
3. In a separate incident, a crew member of a container ship, fell from a height of almost 20 metres, when the base plate of the crane cabin he had just entered in, gave way, and he succumbed to his injuries at the hospital.
4. Preliminary findings revealed that the base plate was severely corroded. Although the company's planned maintenance system covered inspection of cranes, the corrosion of the base plate had not been detected .

Picture 2: Photograph of the base plate of the crane cabin taken after the accident

10. Inspections of areas which are covered by anti-slip mats or any other similar concealments of metallic surfaces, should be carried out in detail especially where the chance of moisture being trapped is high.
